GridLink Interconnector

Preliminary Environmental Risk Assessment

GridLink Interconnector Ltd

October 2020

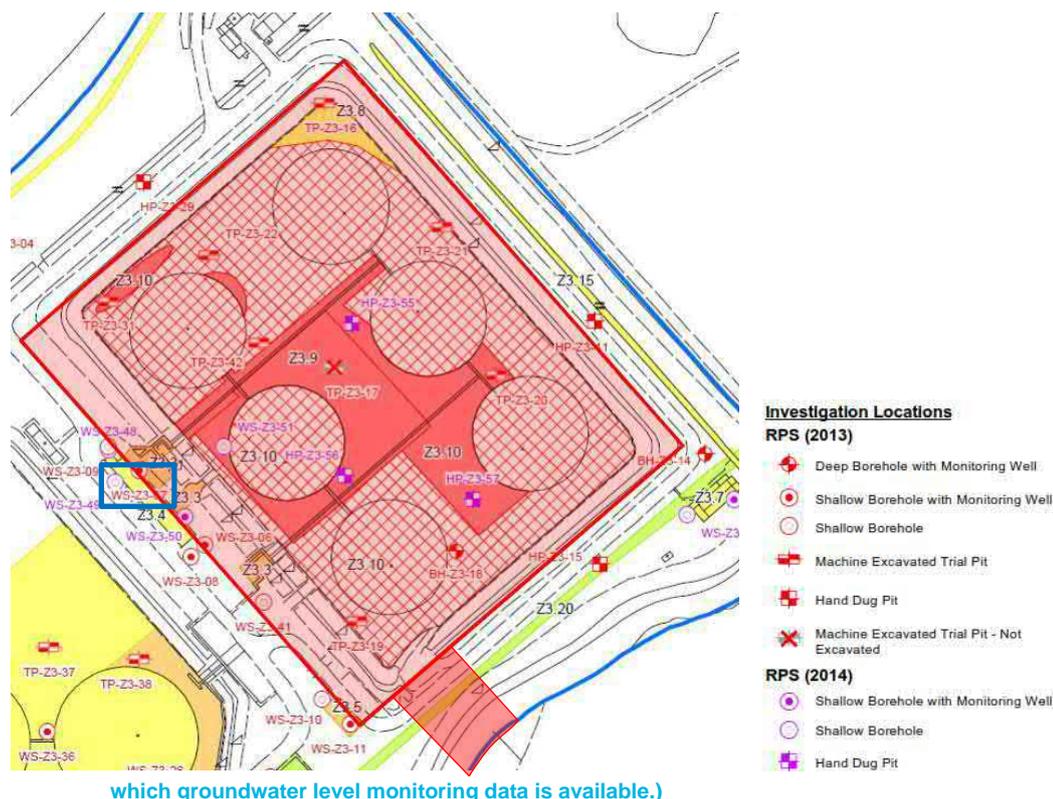
Figure 4-3. Additional Ground Investigation Locations, 2014 (Extract from RPS Drawing No: JER5486-KZ3-005i Rev C)

(The blue square indicates the location of WS-Z3-07, for

- Drilling of 30 no. window sample boreholes to depths of between 0.65 and 4.00m bgl, with one location (WS-Z3-51) targeting the Site (see Figure 4-3);
- Installation of gas and groundwater monitoring well standpipes at various depths within 19 window sample boreholes. WS-Z3-51 (located within the Site) was not installed as a monitoring well; and
- Excavation of 5 no. hand pits dug to depths of up to 0.3m bgl within Kingsnorth Power Station. The hand pits were located to obtain samples of heavy fuel oil (HFO) present at the ground surface within the two tank farm bunds, located within the area of the tank farm. Four of hand pits targeted the Site (HP-Z3-50, HP-Z3-55, HP-Z3-56 and HP-Z3-57).

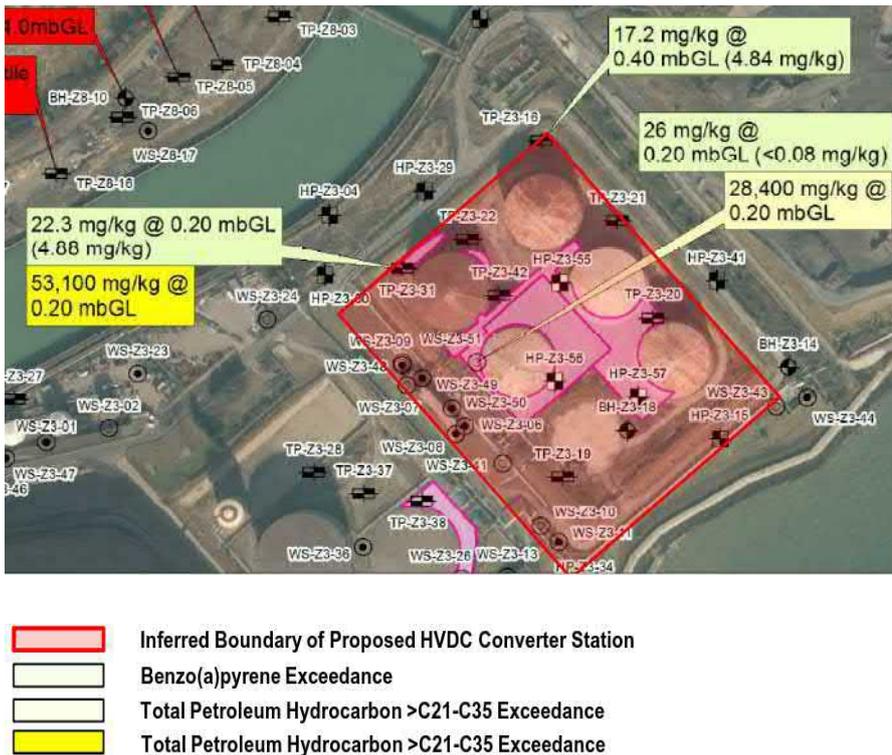
Figure 4-5 Soil exceedances on-site (Extract from RPS Drawing No: JER5486-K-082 Rev D)

- 4.4.3. A Tier 2 human health risk assessment was undertaken using the results of the soil TPH, PAH and PCB laboratory analysis. The assessment combined the results of the ground investigations undertaken by RPS in 2013 and 2014 to assess potential risks to human health from the presence of hydrocarbon contamination within the soils. The assessment compares the contaminant concentrations against relevant SGVs / GACs for the commercial use scenario.
- 4.4.4. On the basis of the laboratory data, and with comparison to commercial Generic Assessment Criteria (GAC), localised human health exceedances were recorded for benzo(a)pyrene (17.2 – 26.0 mg/kg; with a GAC of 14.0 mg/kg) and heavy end (C21 – C35) total petroleum hydrocarbon (TPH) banding (28,400 - 53,100 mg/kg; with a GAC of 28,000 mg/kg) at three intrusive positions (TP-Z3-16, TP-Z3-31 and WS-Z3-51) (Figure 4-5).

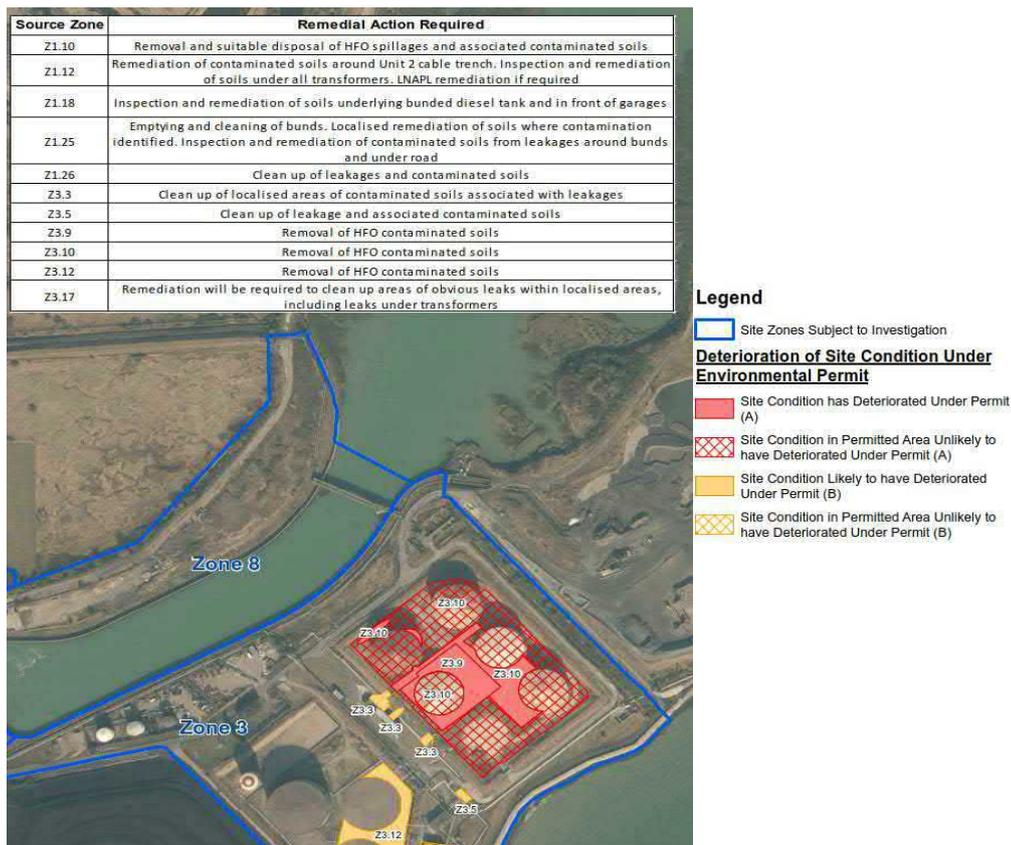
Figure 4-7. Remedial action required (Extract from RPS Drawing No: JER5486-K-086 Rev B)

Source	Contamination Identified	Action Recommended
Z3.9 – Central area of Tanks 1 – 6	No ground investigation data in source location. HFO present at surface	Removal of HFO contaminated soils and remediation verification sampling
Z3.10 – HFO Tanks 1 – 6	Elevated TPH and benzo(a)pyrene in soils and PAHs in groundwater. HFO present at surface	Removal of HFO contaminated soils and remediation verification sampling
Z3.3 – Pipe works leaving tank farm	Elevated TPH and PAHs in groundwater, evidence of hydrocarbons under pipework	Clean up of localised areas of contaminated soils associated with leakages and remediation verification sampling.

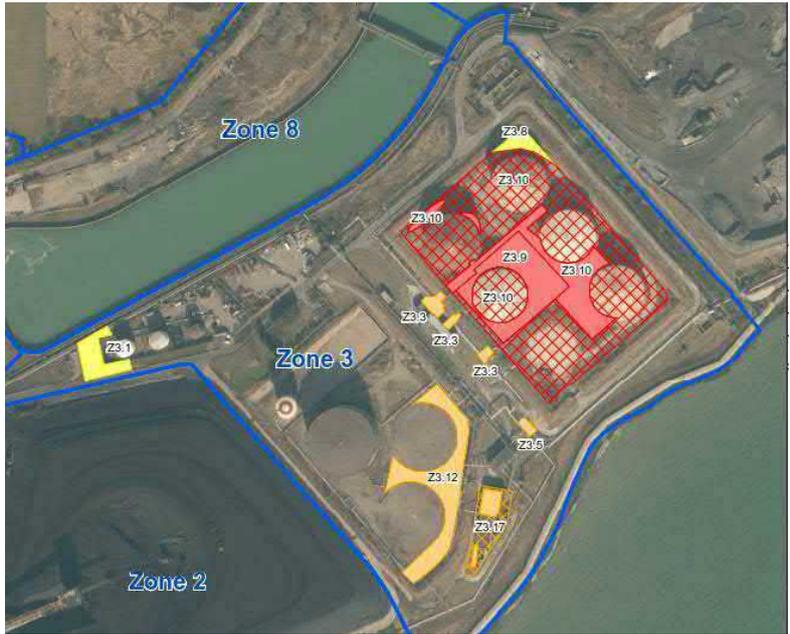
Figure 4-8. Location of Remediation areas Proposed in 2016 (Extract from RPS Drawing No: JER5486-K-087)

- 4.6.1 RPS was commissioned by Uniper Energy Ltd (Uniper) to undertake a remediation options appraisal in relation to contamination identified at Kingsnorth Power Station.
- 4.6.2 The appraisal considered remediation of HFO contaminated soils, residual hydrocarbon contaminated soils, hardstanding that has been contaminated by leaks and spillages and localised areas of groundwater contaminated with hydrocarbons.
- 4.6.3 Table 4-3 below summarises the CSLs where remediation was deemed to be required at the Site. Figure 4-8 identifies the location of these CSLs.

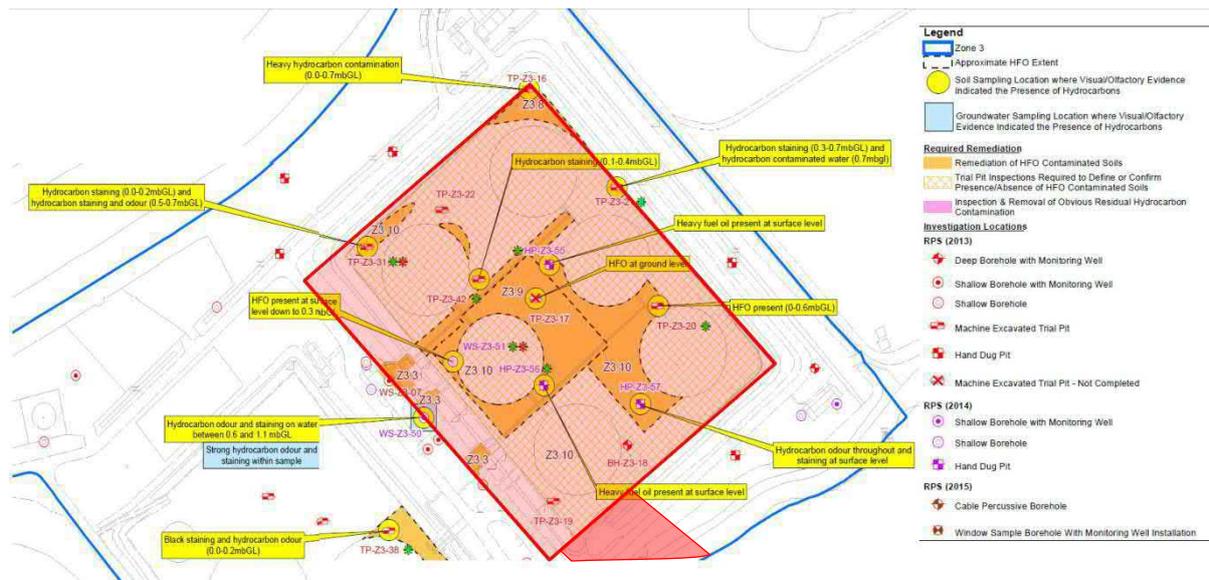
Figure 4-10. Proposed remedial works at the Site (Extract from RPS Drawing No: JER5486-KZ3-012i Rev A)

- 4.7.4 On the basis of the available information, RPS assumed that a total of 7,726m³ of material would require remediation, based on the assumption of excavation depths of 0.5m within the tank farm area, and 1.5m in the area of the above ground pipes on the western boundary of the Site. No areas of hardstanding were included within these estimations. Remediation options considered for soil by RPS included ex-situ thermal desorption or ex-situ bioremediation with 50% off-site disposal. No groundwater remediation was considered to be required.

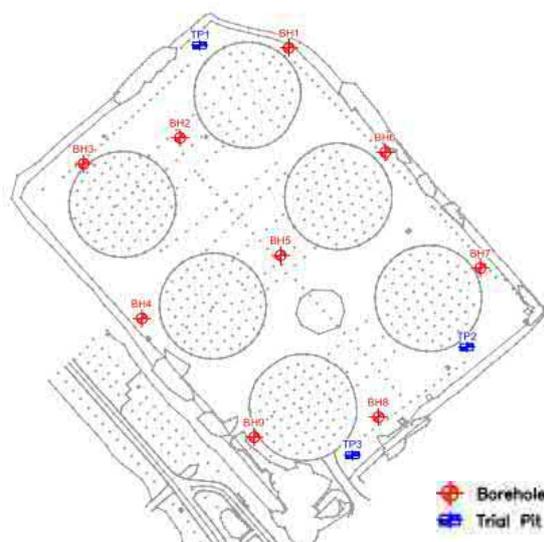
Figure 4-11. Investigation location (Extract from SOCOTEC, April 2020. Drawing No: A2)

4.9.3 Geo-environmental laboratory testing was carried out on the soil samples recovered during the fieldwork, and included pH, sulphate, sulphide, chloride, cyanide, polychlorinated biphenyls (PCBs), volatile organic compounds (VOCs), semi-volatile organic compounds (SVOCs), total organic carbon, volatile and extractable hydrocarbons, heavy metals (arsenic, barium, beryllium, boron, cadmium, chromium, copper, lead, mercury, nickel, vanadium and zinc) and asbestos. The results are reported in Section 4.10.

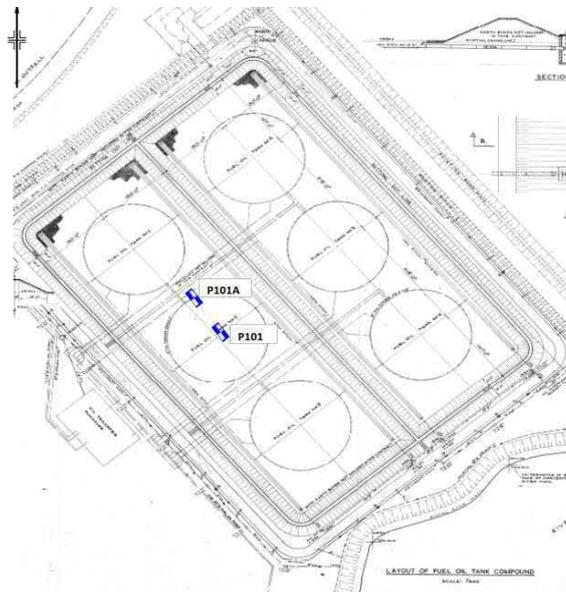
Figure 4-12. Exploratory locations Plan (Extract from SOCOTEC, April 2020. Drawing No: A2)

- 4.11.2 The investigation, carried out in January 2020, consisted in breaking through a section of one of the former tank base slabs, using a mechanical excavator and hydraulic breaker unit, to obtain samples of the underlying piles for subsequent laboratory testing. On completion, the excavation was backfilled, and the broken concrete from the slab placed at ground level.

- 4.11.3 Three piles were encountered within the excavation. The piles were noted to be circular, with reinforcement bar located at varying distances from the outer wall. The piles were surrounded by a thin metal sleeve. The concrete of the overlying tank slab was noted as being reinforced.

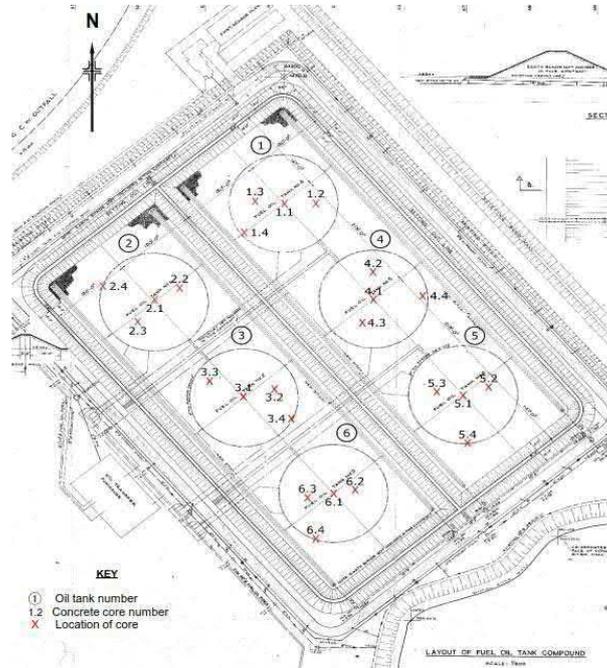
Figure 4-13. Concrete Core Location Plan (Extract from SOCOTEC, April 2020. Drawing No: A2)

4.12.2 The fieldworks included one core completed in the central part of each tank base, one on the outer rim, and the remaining two over the main area of the slab, as indicated in Figure 4-13. The cores were undertaken utilising bolt down electrical coring equipment. Testing on a representative selection of cores included strength, cement content and cement / aggregate ratio. The results are included in the Factual Report on Tank Base Piling Inspection (SOCOTEC, April 2020)

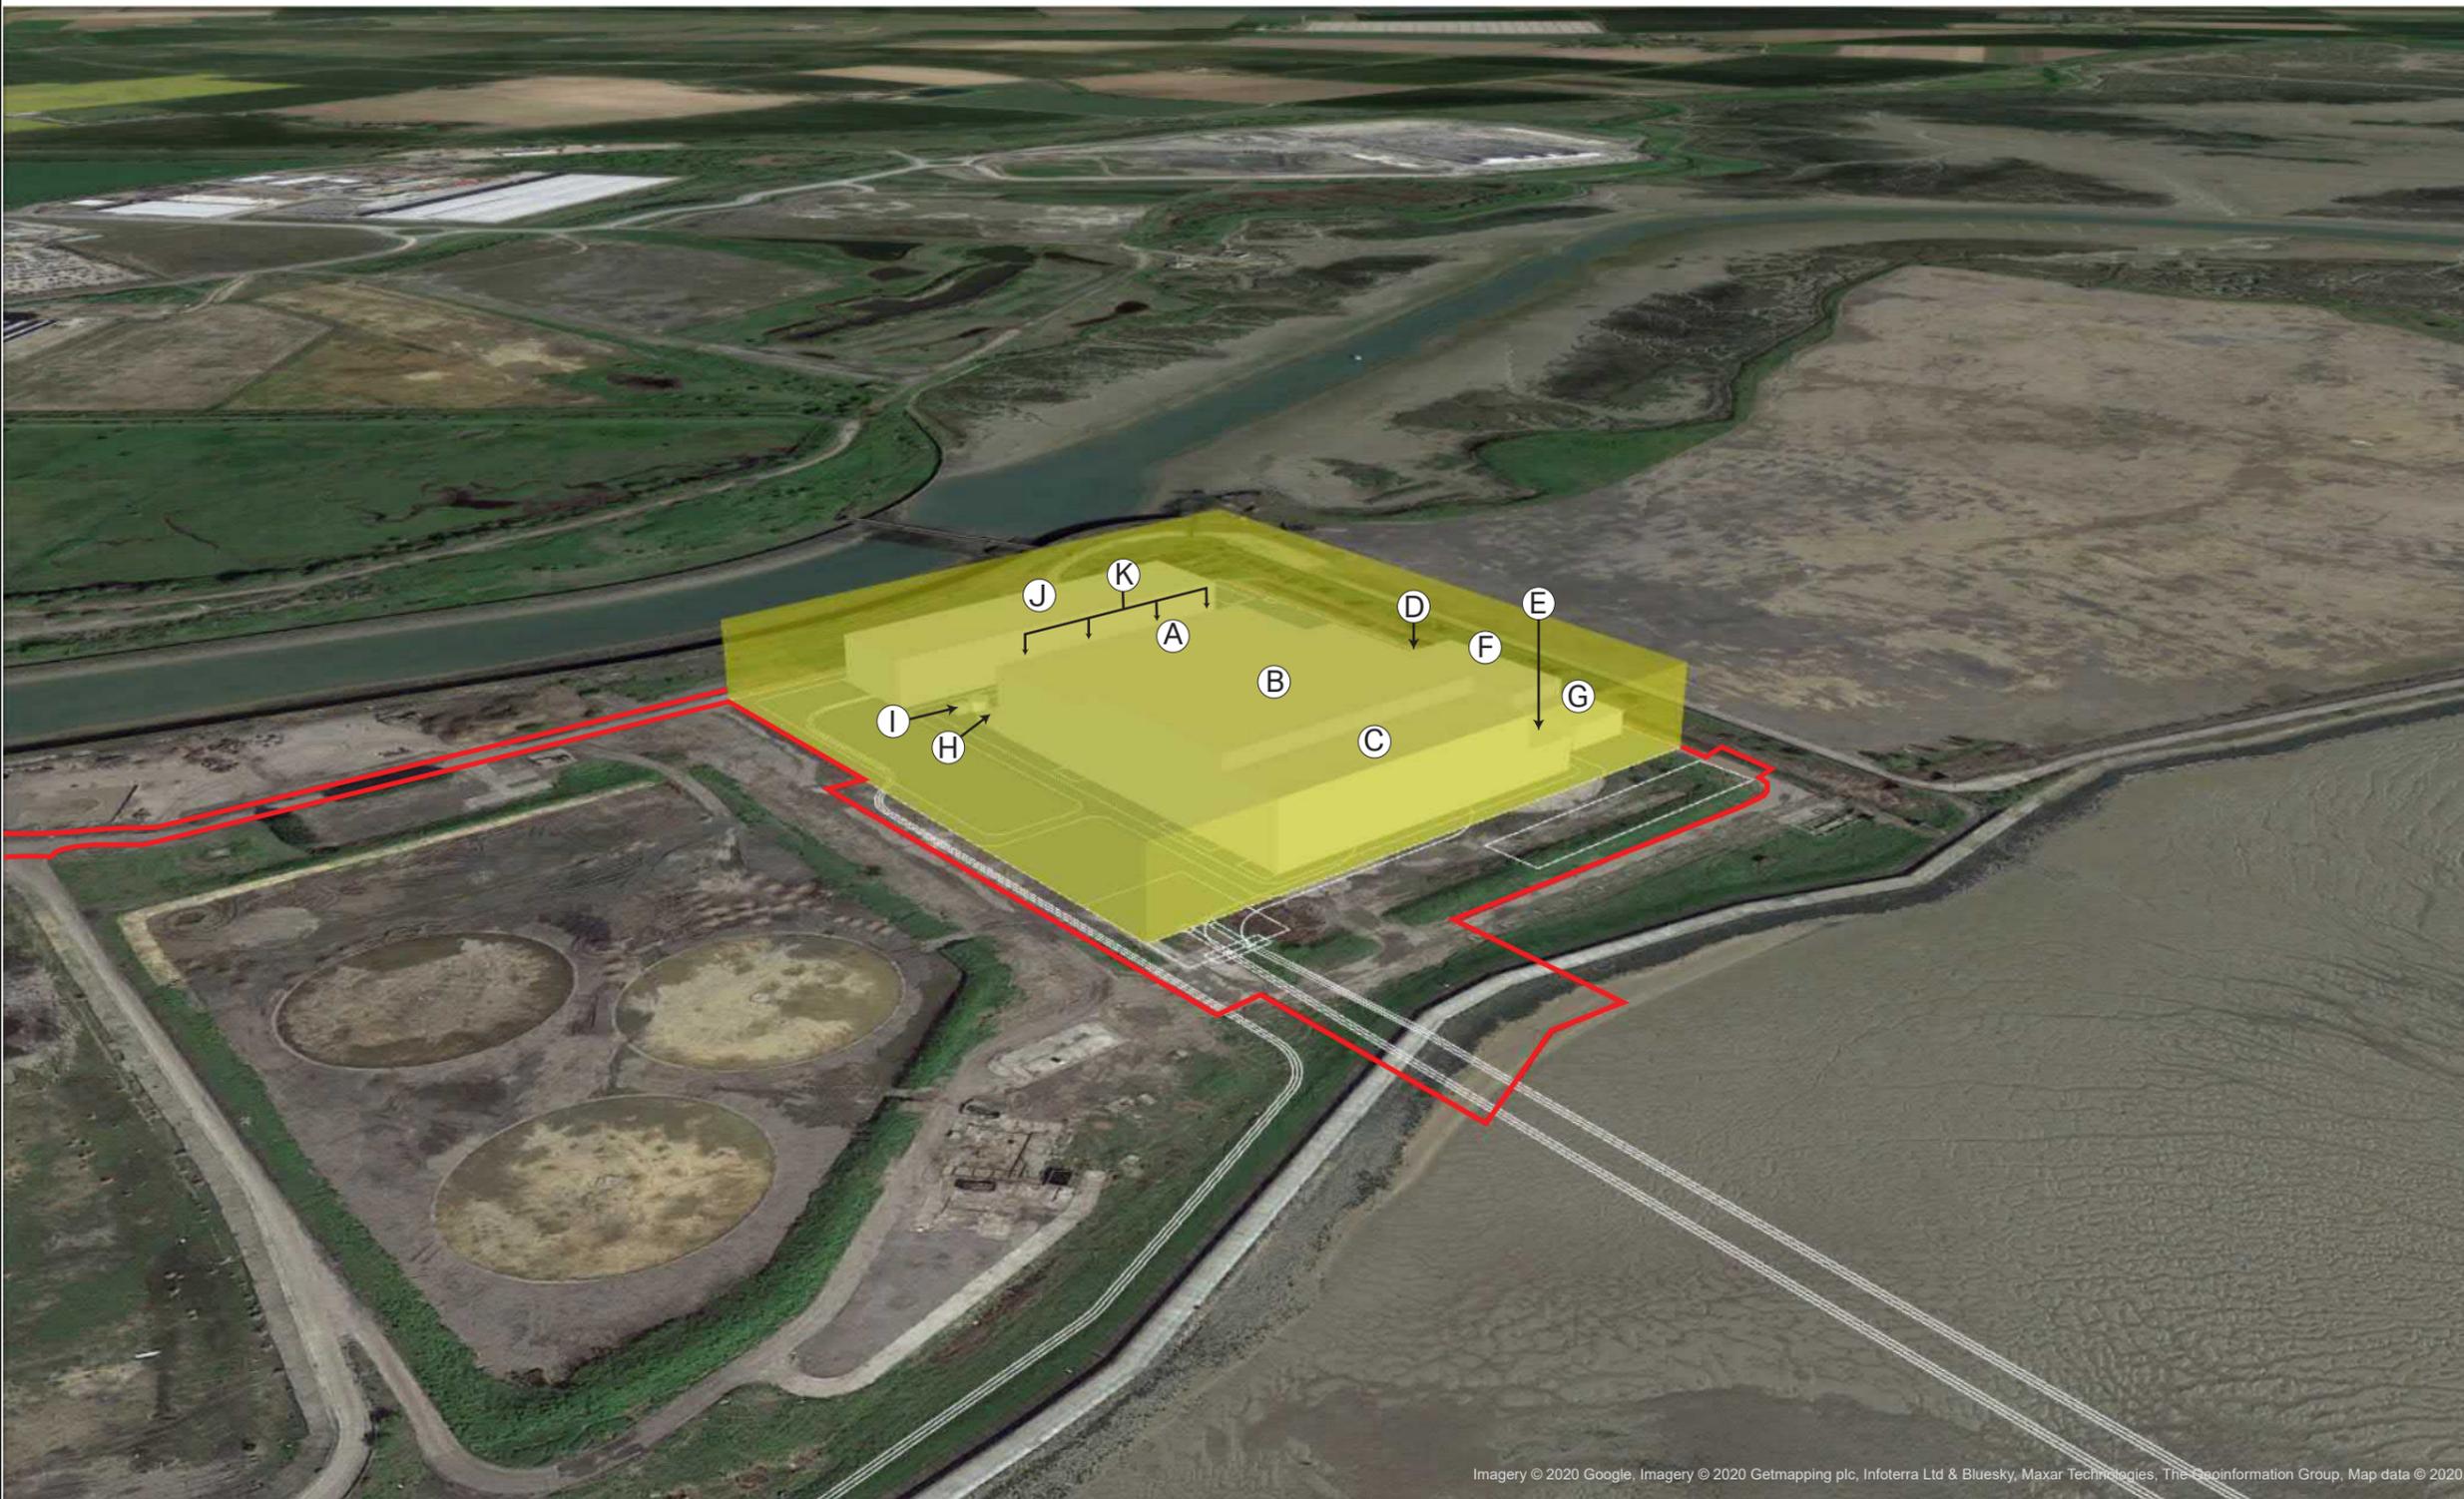
- A - Reactor Hall, 30 x 87m, height 20m
- B - Valve Hall, 57 x 87m, height 25m
- C - Dc Hall, 21 x 87m, height 20m
- D - Service Building, 46 x 16m, height 10m
- E - Spares/Workshop Building, 20 x 16m, height 10m
- F - Spares/Maintenance Building, 45 x 20m, height 10m
- G - Cooling Fans, 20 x 20m, height 7m
- H - Diesel Generator, 10 x 10m, height 3m
- I - Fire-fighting Storage, height 3m
- J - AC Yard, 117 x 30m, height 15m
- K - Transformers, 17 x 7m, height 5m

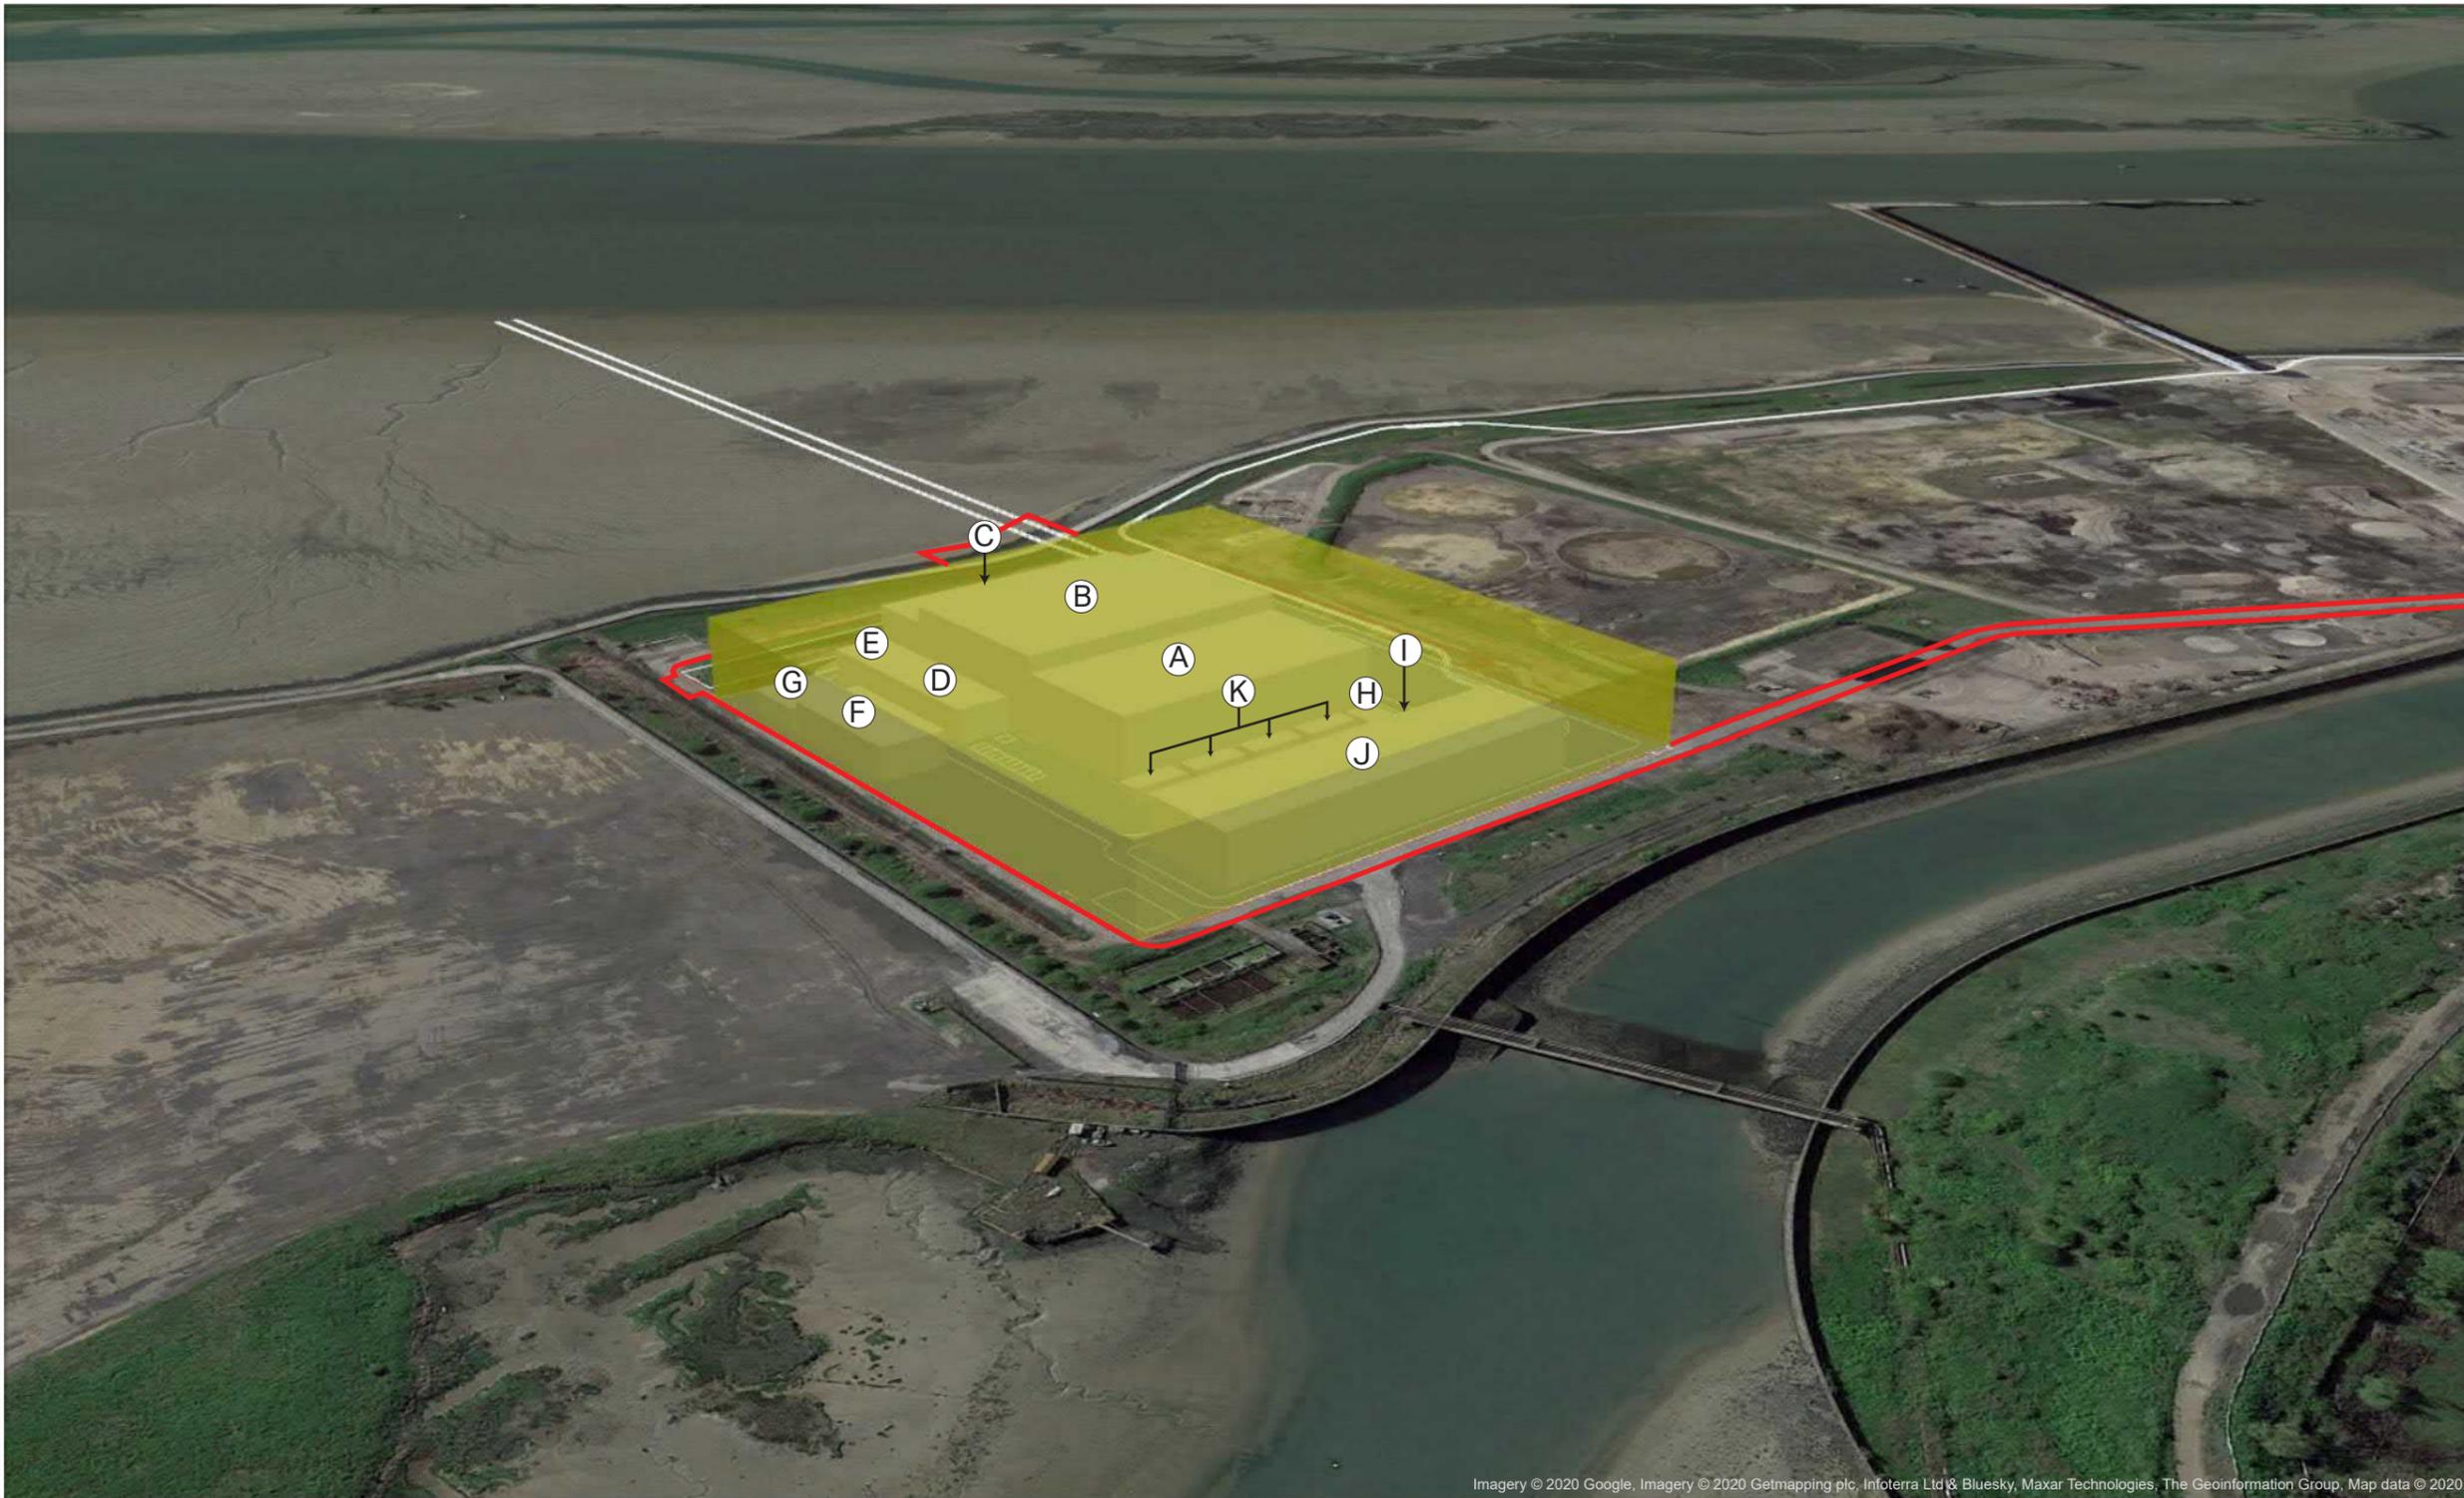
- A - Reactor Hall, 30 x 87m, height 20m
- B - Valve Hall, 57 x 87m, height 25m
- C - Dc Hall, 21 x 87m, height 20m
- D - Service Building, 46 x 16m, height 10m
- E - Spares/Workshop Building, 20 x 16m, height 10m
- F - Spares/Maintenance Building, 45 x 20m, height 10m
- G - Cooling Fans, 20 x 20m, height 7m
- H - Diesel Generator, 10 x 10m, height 3m
- I - Fire-fighting Storage, height 3m
- J - AC Yard, 117 x 30m, height 15m
- K - Transformers, 17 x 7m, height 5m

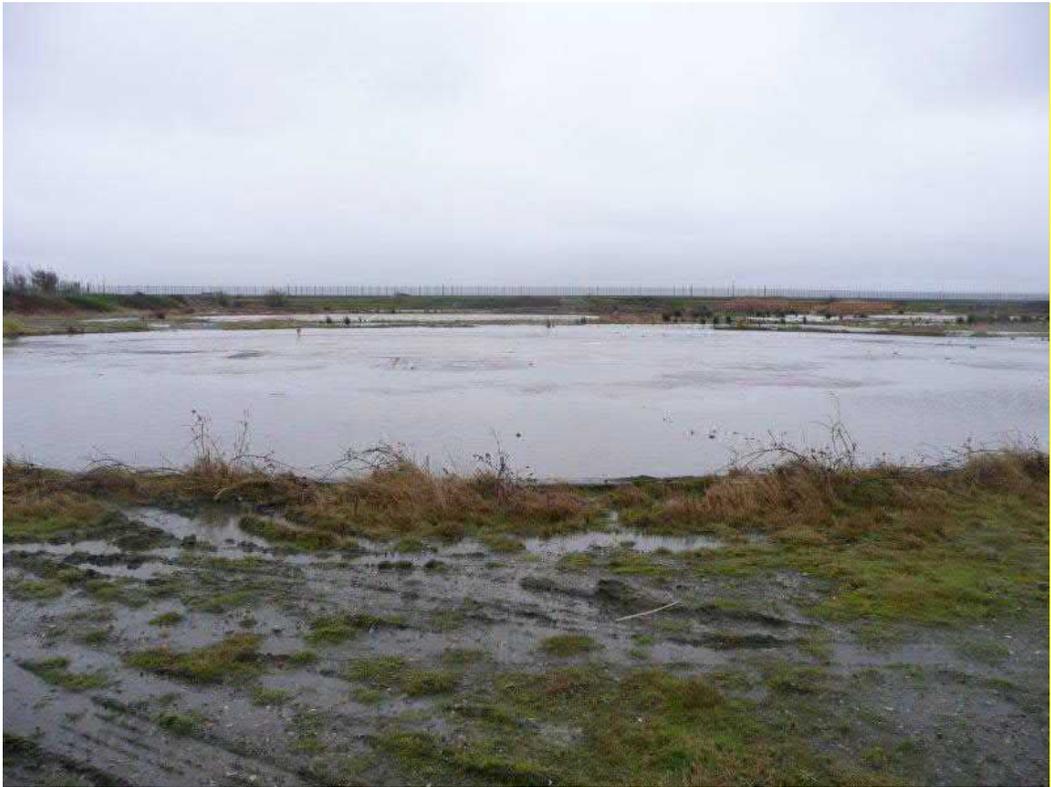
Photo No. 1	Date: 27 th February 2020

<p>View of Site, including hardstanding associated with the footprints of the former storage tanks. River Medway in the background.</p> <p>The photograph aspect is south-east.</p>

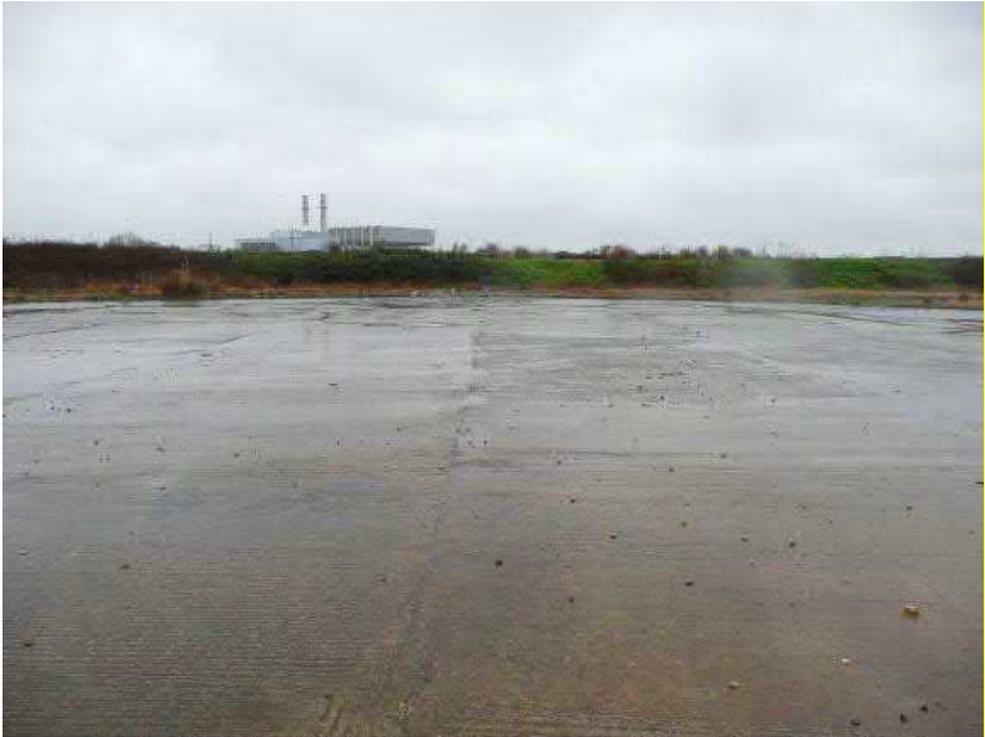
Photo No. 2	Date: 27 th February 2020

<p>View of Site, including hardstanding associated with the footprints of the former storage tanks and the earth bund beyond. Damhead Creek Power Station in the background.</p> <p>The photograph aspect is north-west.</p>

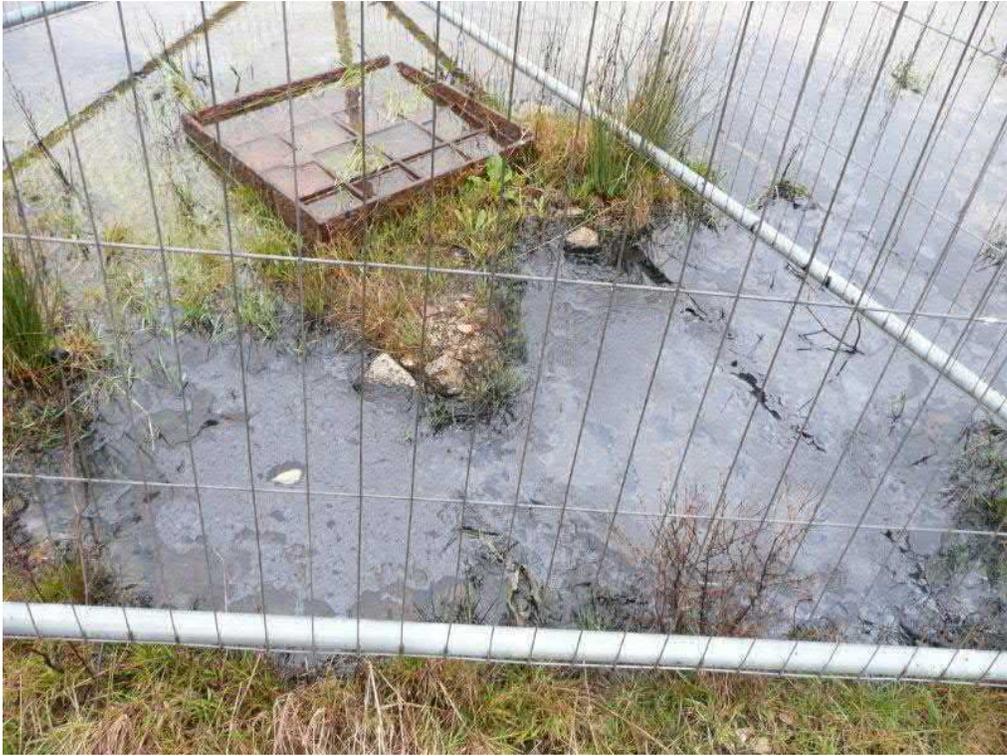
Photo No. 3	Date: 27 th February 2020

<p>Evidence of hydrocarbon sheen in a puddle of water was observed at the south-western extent of the Site. The area was fenced.</p>

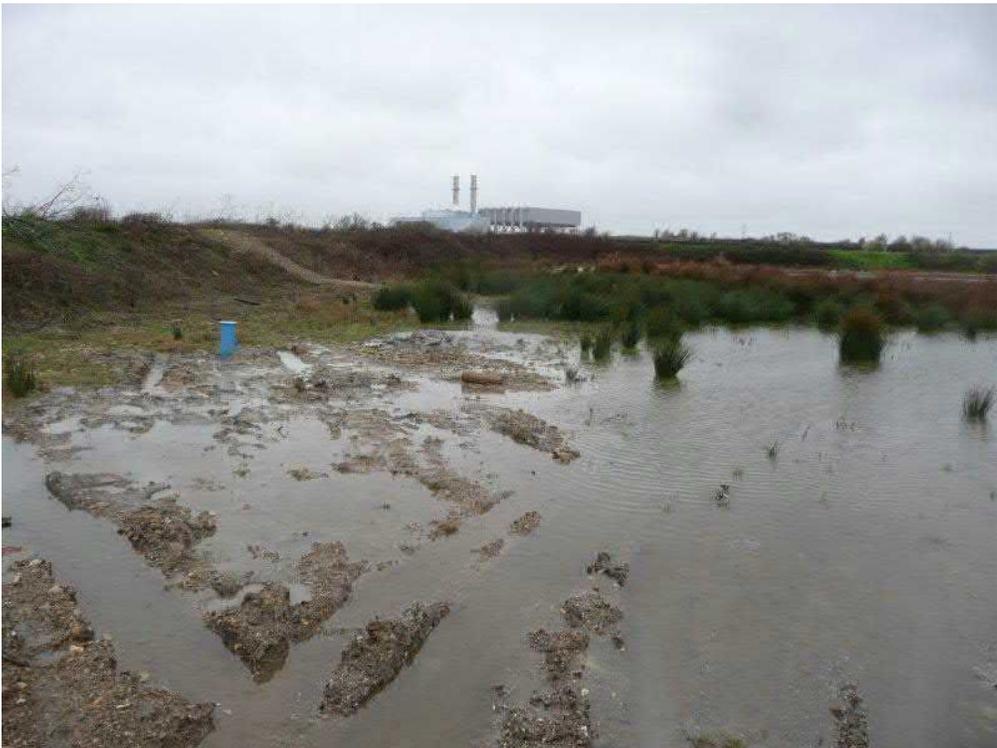
Photo No. 4	Date: 27 th February 2020

<p>View of the western aspects of the Site. During the site walkover, a number of historical site investigation locations were observed on the Site, including seven monitoring wells. Damhead Creek Power Station in the background.</p> <p>The photograph aspect is north-west.</p>

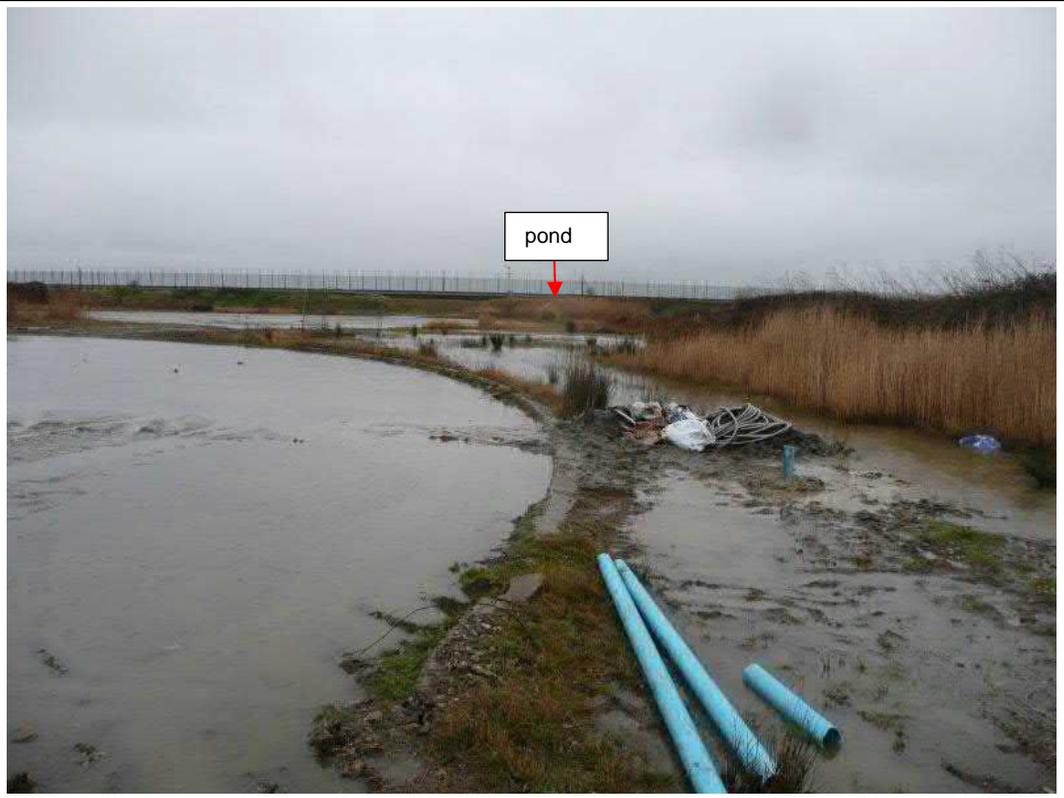
Drilling materials were observed at the Site. A small pond, covered in vegetation, is at the south-western corner of the Site.

The photograph aspect is south.

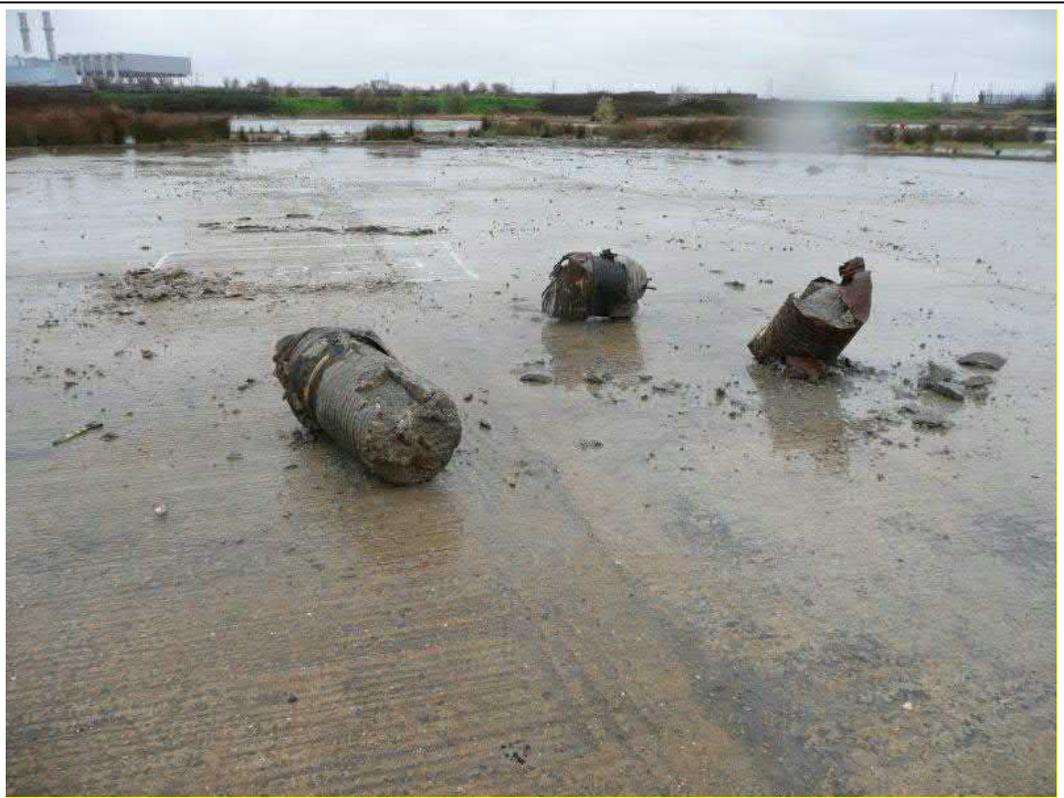
Photo No. 6	Date: 27 th February 2020
-----------------------	--

Debris assumed to be from the decommissioning were abandoned at the Site.

The photograph aspect is north-west.

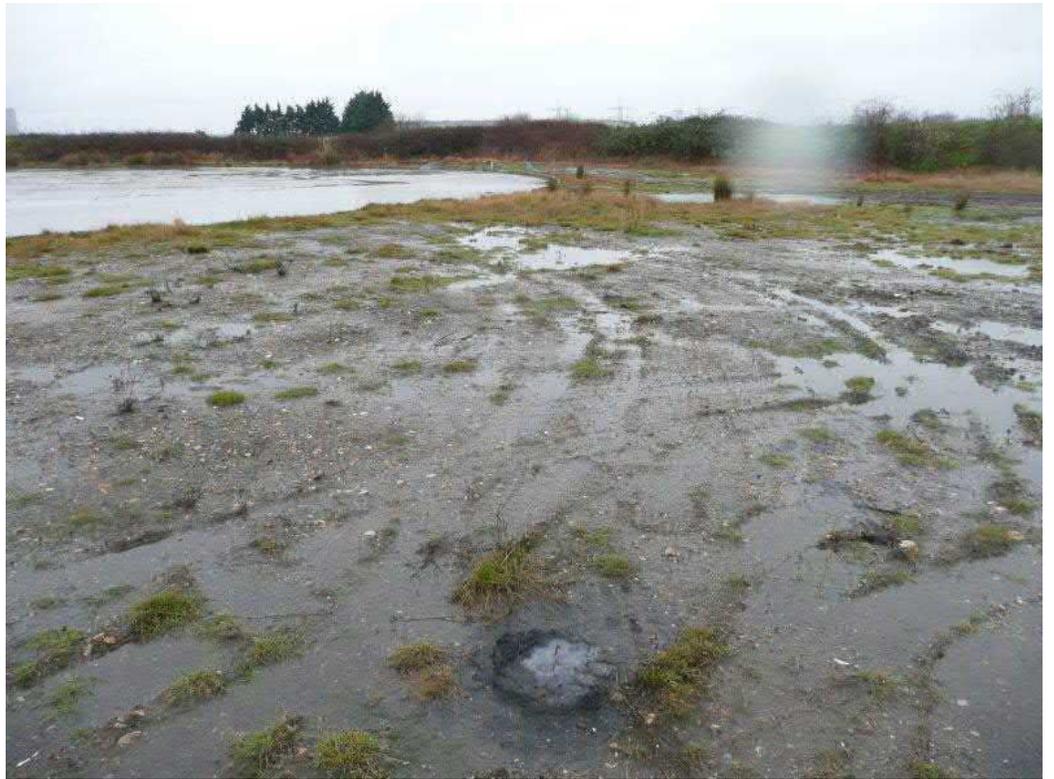
Evidence of recent site investigations (including hydrocarbon staining) was observed on the Site.

The photograph aspect is south-west.

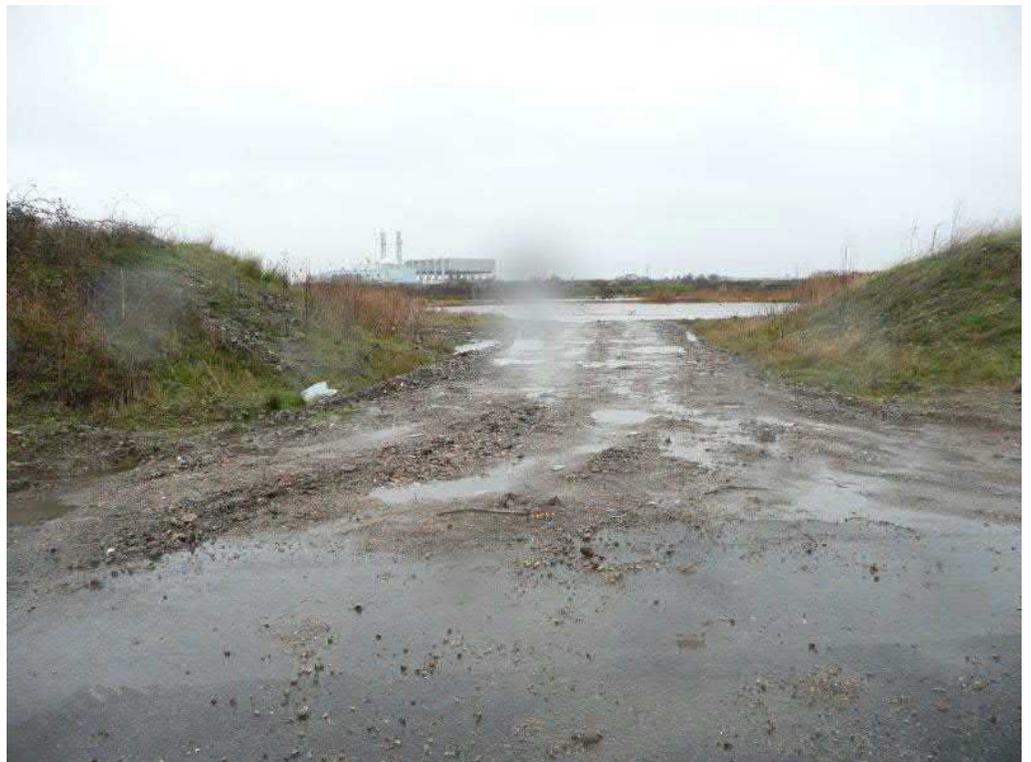
Photo No.
8

The area is bounded by the vegetated earth bund and can be accessed from the south-west.

The photograph aspect is north-west.

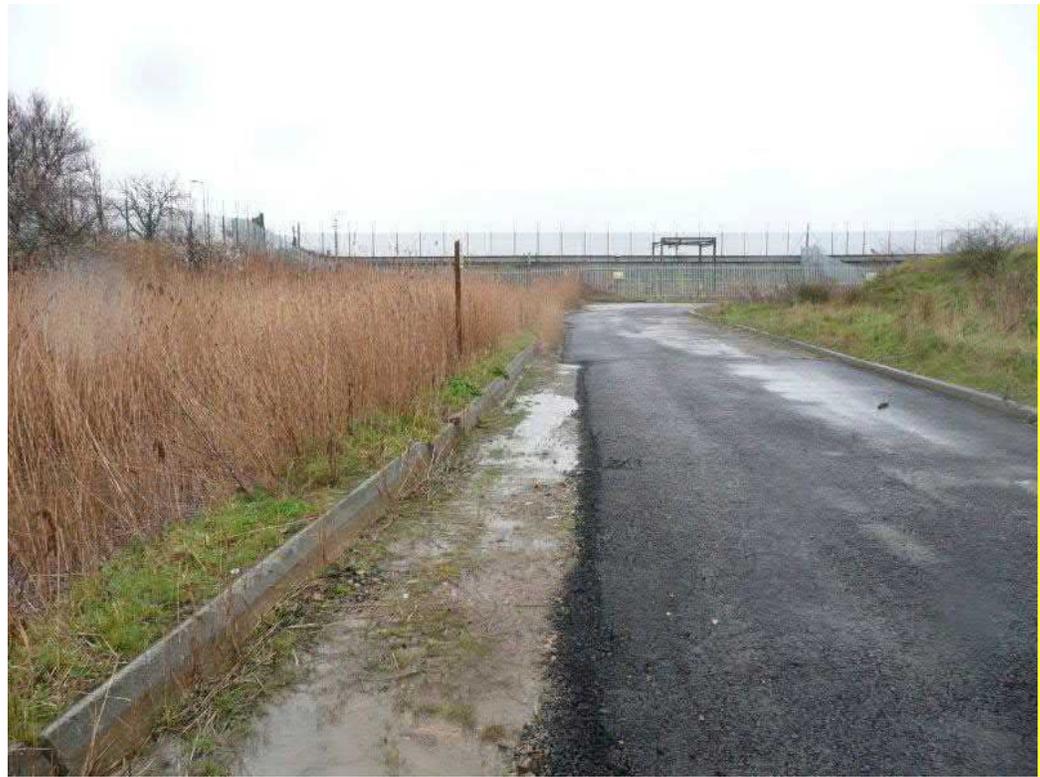
Photo No. 9	Date: 27 th February 2020
-----------------------	--

View of the drain along the north-eastern boundary of the Site. It is understood that the water from the network of drains surrounding the Site passes through a two bay interceptor. The interceptor (in the background of the photo) has separators and skimmers to collect oil.

The photograph aspect is south-east.

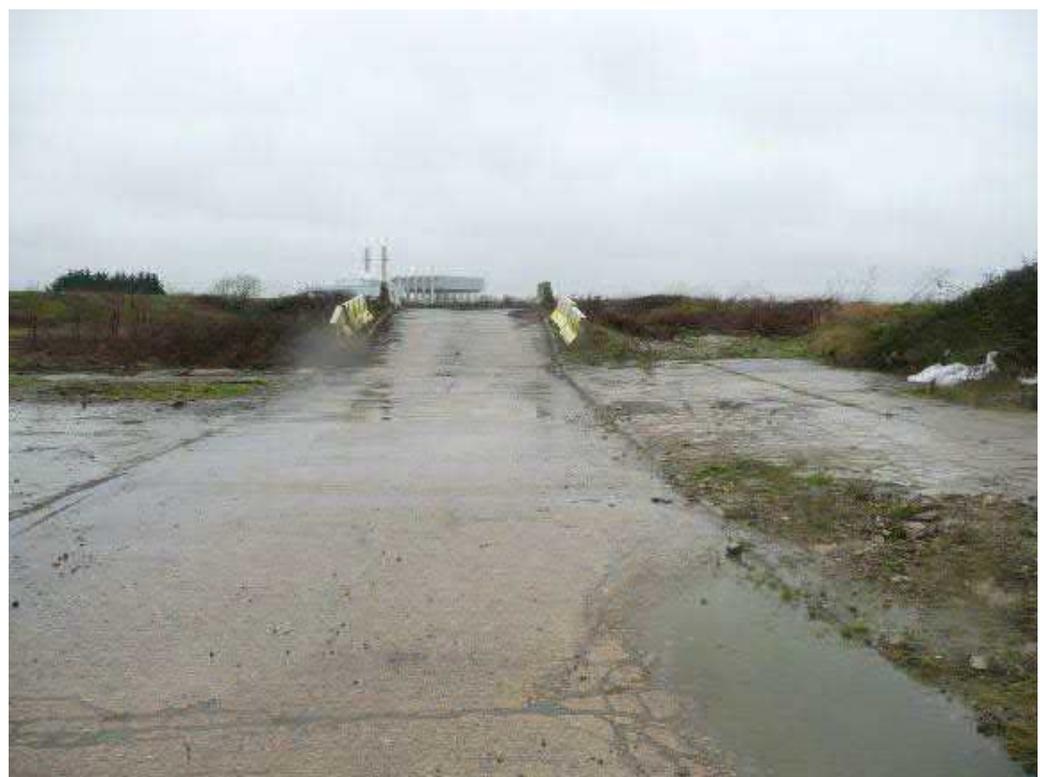
View of the road along the south-western boundary of the Site.

The photograph aspect is north-west.
