GridLink Interconnector

Preliminary Environmental Risk Assessment

GridLink Interconnector Ltd

October 2020

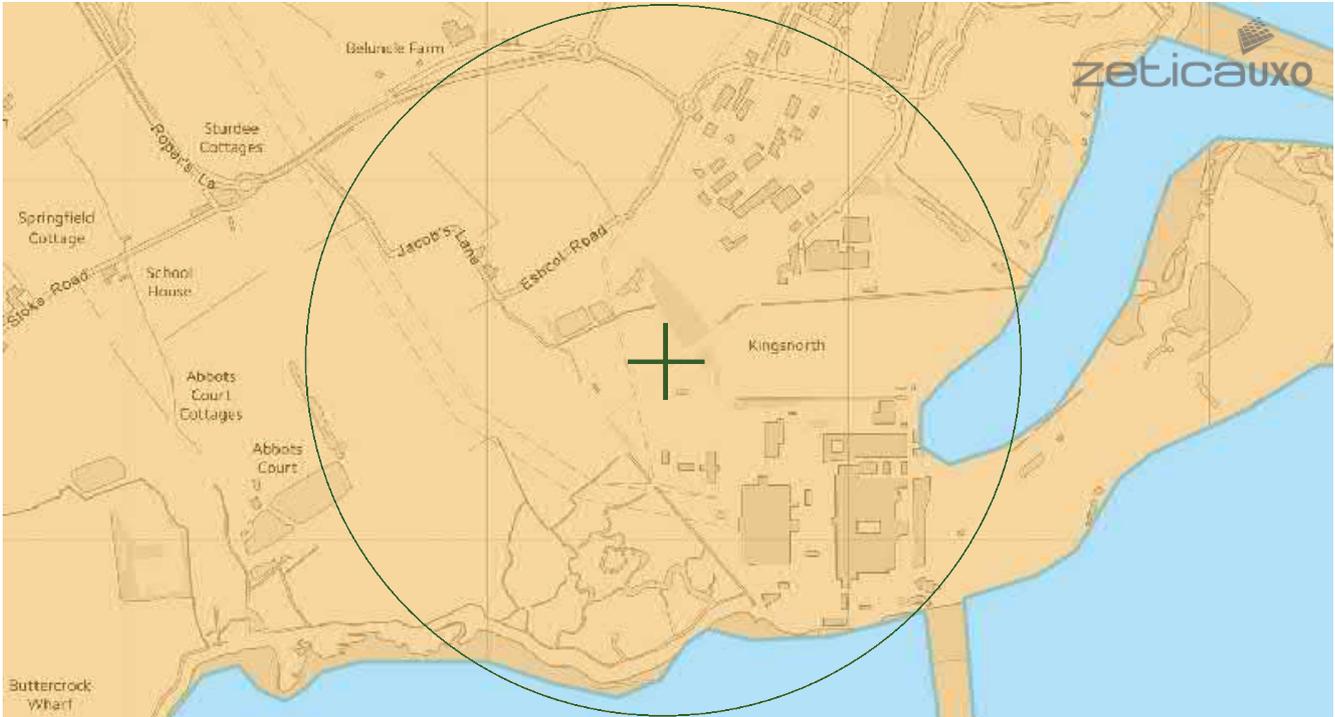
UNEXPLODED BOMB RISK MAP

Location: Kingsnorth, Medway
Map Centre: 580500,172500

Generally, we recommend that a detailed UXO desk study and risk assessment is undertaken for sites in a moderate or high UXB risk area.
